# Manhole Inspection Summary

Manhole # S37AA\_031MH

Insp Date: **9/2/08 12:53 PM**

**Location** Address: **501 constitution st**

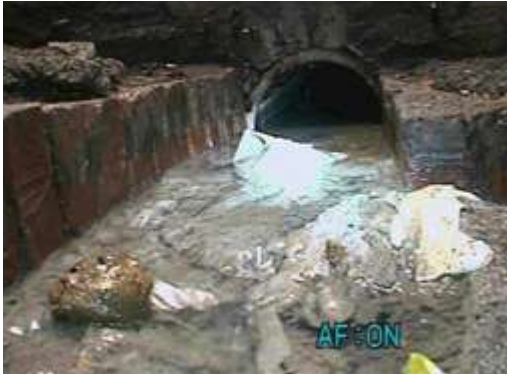
Defect 4

Condition: ☐ Sound ☐ Cracked ☐ Root Intrusion ☐ Deteriorated ☐ Leaks ☒ **Debris**

channel debris

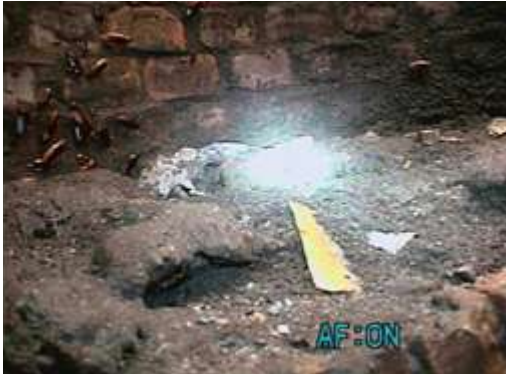
Defect 3

Condition: ☐ Sound ☐ Cracked ☐ Root Intrusion ☐ Deteriorated ☐ Leaks ☒ **Debris**

bench debris

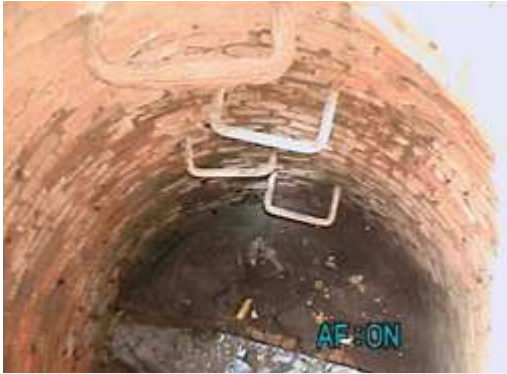
Defect 2

Count: **4** Missing: **0** ☒ **Corroded**

corroded steps

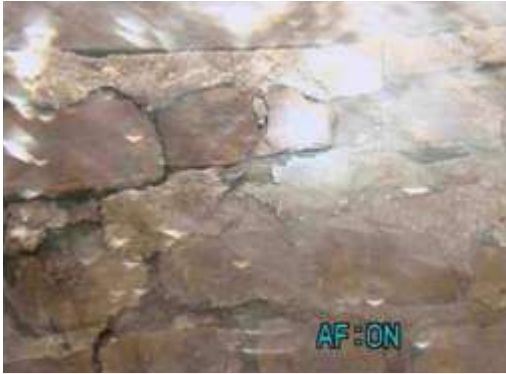
Defect 1

Condition: ☐ Sound ☒ **Cracked** ☐ Root Intrusion ☐ Loose Brick ☐ Deteriorated

cracked chimney frame adj

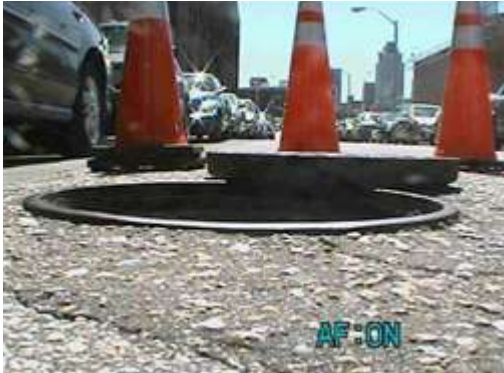
### Defect 5

Diameter: **26** (in.) Length: **0** (in.) Dist A/B Grade: **1** (in.)

cover above pavement

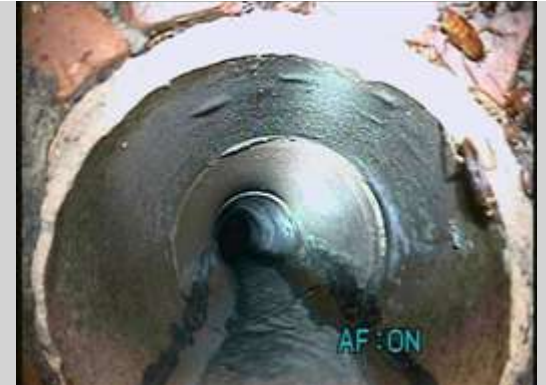
12 O'Clock Outflow

8 in. Circular Gravity Sewer  
Pipe Out @ 12 O'Clock

Pipe Material: **Clay** ☐ Pipe Lined

Invert Depth: **8.10** (ft.) Flow Characteristics: **Fast**

Deposits: ☒ None ☐ Mud ☐ Sludge ☐ Debris ☐ Grease

Infiltration: **None** Pipe Seal Cond: **Unknown**

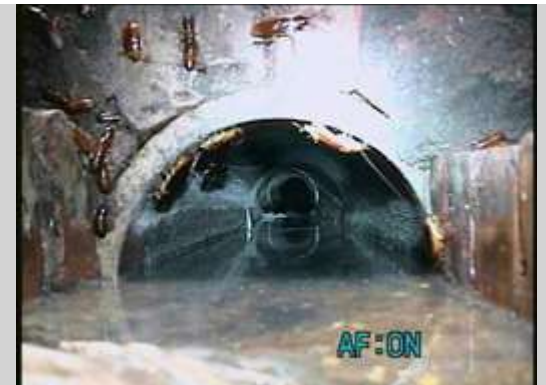
6 O'Clock Inflow

8 in. Circular Gravity Sewer  
Pipe In @ 6 O'Clock

Pipe Material: **Clay** ☐ Pipe Lined

Invert Depth: **7.92** (ft.) Flow Characteristics: **Slow**

Deposits: ☒ None ☐ Mud ☐ Sludge ☐ Debris ☐ Grease

Infiltration: **None** Pipe Seal Cond: **Unknown**

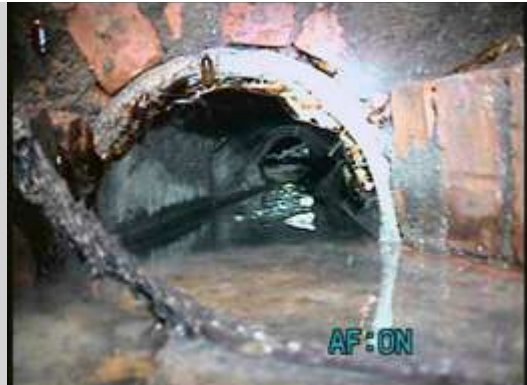
9 O'Clock Inflow

8 in. Circular Gravity Sewer

Pipe In @ 9 O'Clock

Pipe Material: **Clay** ☐ Pipe Lined

Invert Depth: **7.83** (ft.) Flow Characteristics: **Slow**

Deposits: ☒ None ☐ Mud ☐ Sludge ☐ Debris ☐ Grease

Infiltration: **None** Pipe Seal Cond: **Unknown**
